# Curator's Choice

## *Electrolysis PSA*

By: Nichole Doub, Head Conservator,  
Maryland Archaeological Conservation Lab

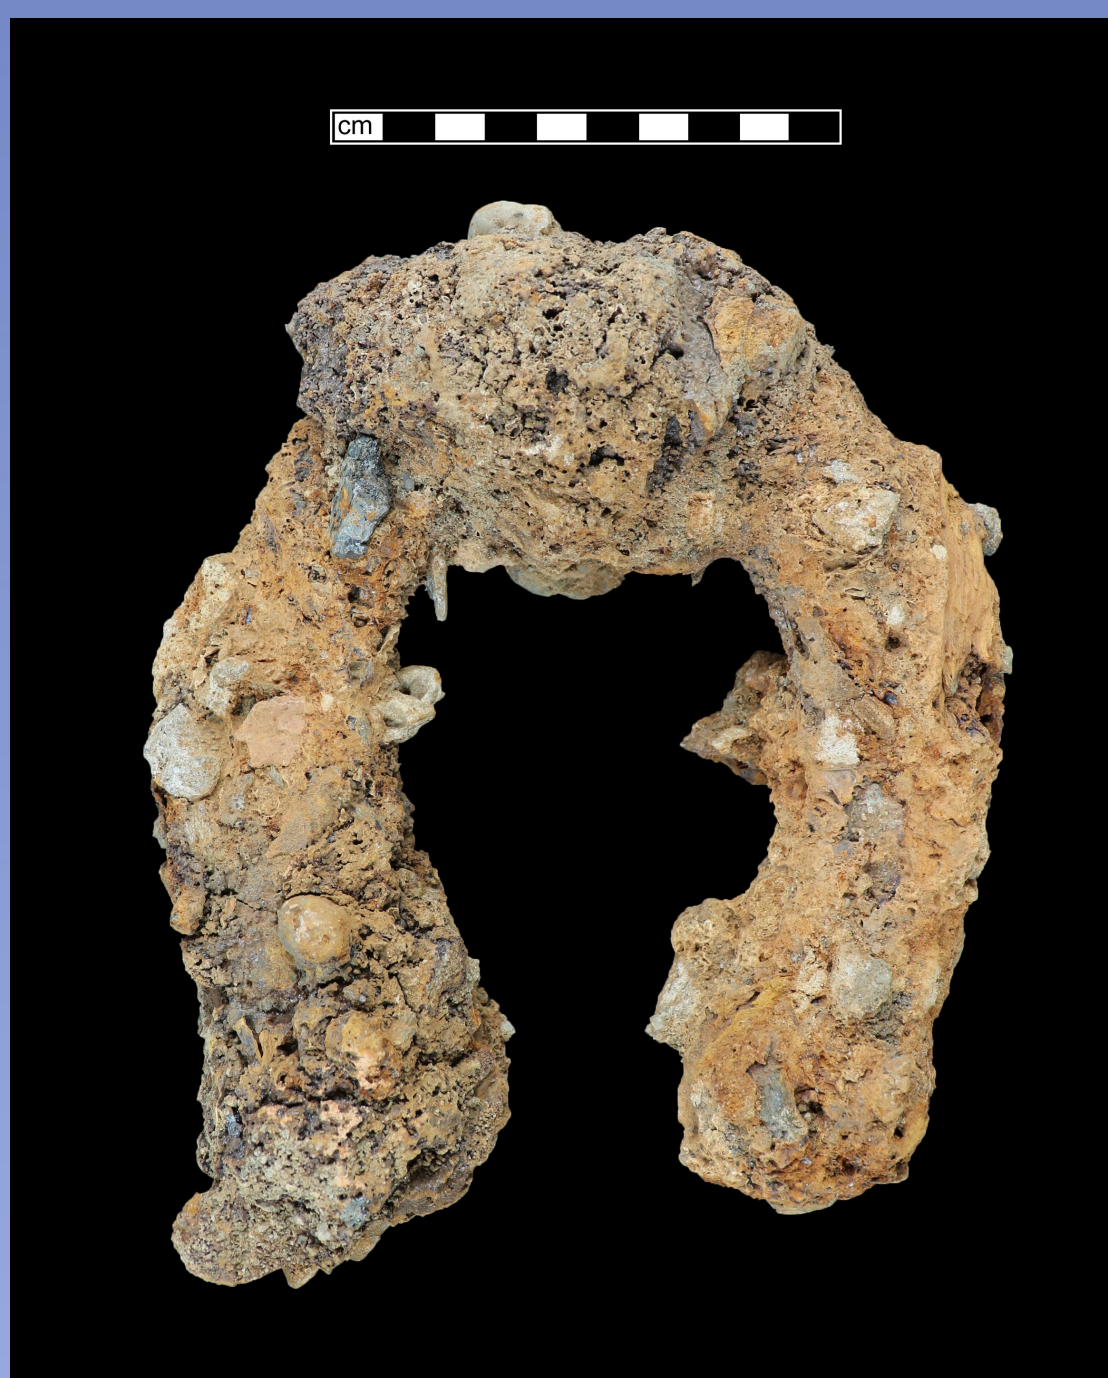
**T**he example provided by this archaeologically recovered horseshoe illustrates the damage and loss of information that can occur when an artifact is subjected to electrolysis. Upon visual inspection the object is robust (Figure 1), but x-radiography shows a different story. The object is more heavily degraded than it initially appeared. The original surface of the object is suspended in the corrosion products and visible only in outline (Figure 2).

Figure 1. Horseshoe before treatment.

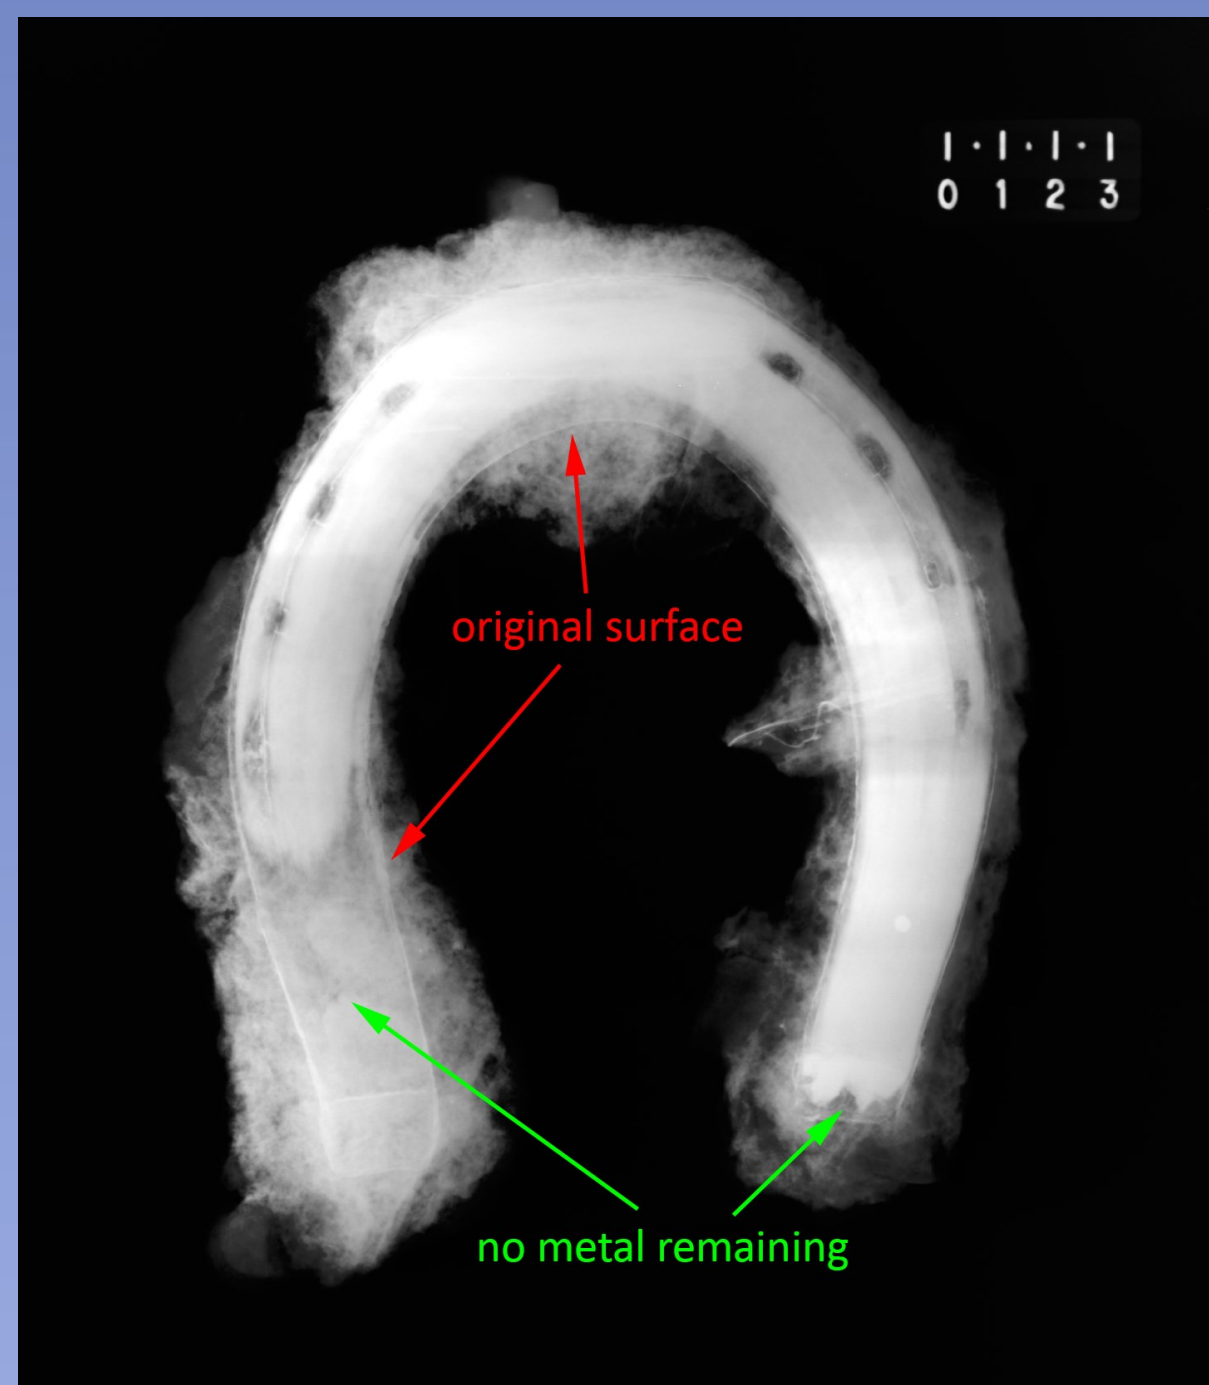
Figure 2. X-ray of horseshoe showing outline of original surface and material loss.

**W**ithout the x-ray images, archaeologists would have lost all the original dimensional and surface information. The x-ray also indicates to conservators that this object is not a good candidate for an expensive treatment process. X-radiography is a very good, inexpensive means to survey metal collections. It can provide accurate identifications, provide diagnostic measurements, and record preservation conditions. The MAC Lab is an excellent resource for x-radiography services, but you can also build relationships with local doctors, dentists, security offices (i.e., courthouses), large animal veterinarians, etc. to help image your artifacts. Accurate recording of artifacts is a superior option to destroying data with inappropriate preservation methods.

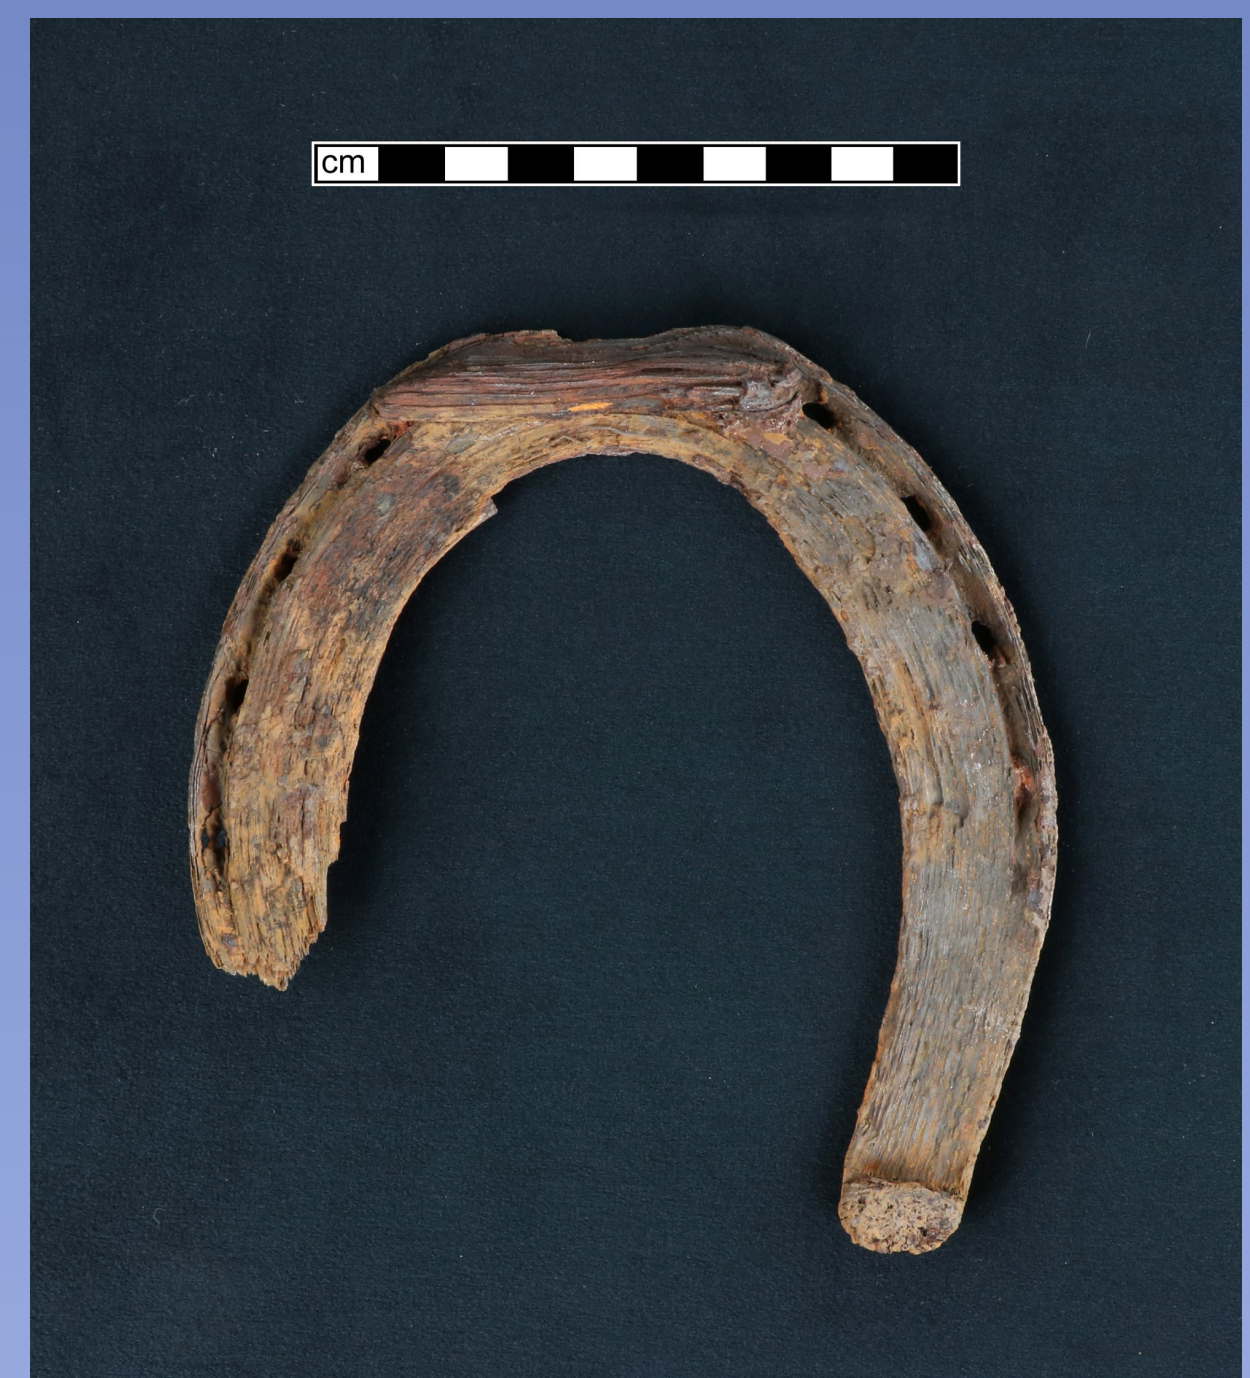
The rope-like structure of the wrought iron is an indicator of the deterioration. While the metal core is present in some areas of the object, one quarter of the horseshoe has been completely replaced by corrosion product (Figure 3). Any treatment would be more damaging to the artifact than preserving the corrosion product that is providing protection to the remaining metal. This horseshoe was exposed to ER to illustrate the extent of loss and damage this process can incur.

Figure 3. After electrolytic reduction which destroyed all original surfaces and exposes metal core.
