Restoration of the East & West Barracks
At Fort Frederick State Park,
Washington County, Maryland

Project No. P-12-91

PHASE #1
Grading & Excavation of New
barracks Footers
March 10 — 28, 1975

PHASE #2
EXCAVATION OF ELECTRICAL
LINE AND PORCH FOOTER
TRENCHES
AUGUST 12—13, 1975

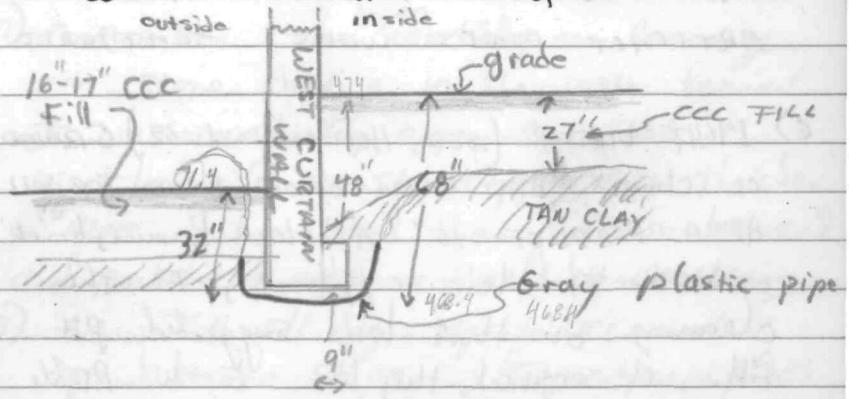
SKETCH IS LOOKING NORTH

2) hole for temporary electrical outlet dug below wooden catwalk west curtain wall

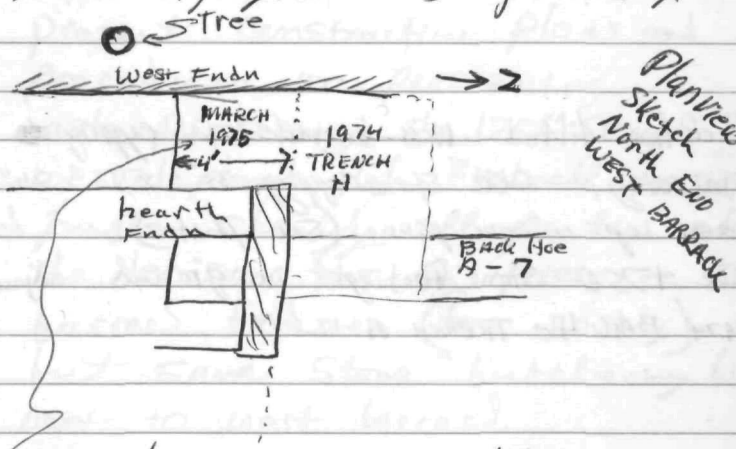
2) I dug into the South Profile of Trench H between the Stone fireplace Footing and the west wall. To look for architectural features. None were found. Instead dig the black humus & rubble lens noted for Backhoe trenches A 3 & 4 30-36 inch deep this location also had a 4" thick humus & rubble lens resting on the tan-beige clay subsoil. This rubble lens contain 18th Century Materials: 1) brick rubble 2) mortar 3) wire, 4) sq Nails, 5) bone 6) 1 delft shard 7) 2 Saltglaze Shards 8) 1 glass frag.

TAN clay sub soil 34" below Surface

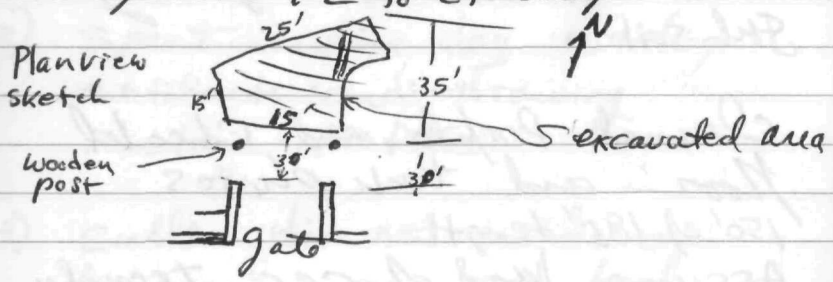
The above irregularly-shaped area was roughly dug out — the floor was uneven & with dips.

— I could not recognize any features or meaningful soil changes.

A Possible Streak black Stain on The Floor in NE corner may be the base of a CCC Trench!

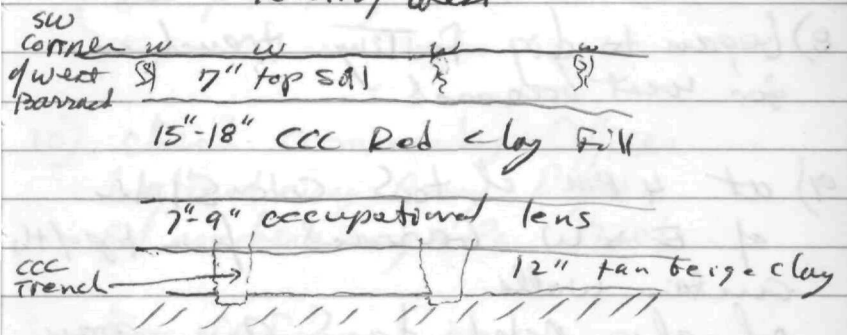
looking west

6) South end of west wall profile with Stone fndn remove. revealed 2 CCC Narrow 1'x2' trenches (See Photos)

7) North end of west wall profile with Stone fndn remove also revealed CCC raise fill and a 45 Ft long dip 5 to 9' south of N Fndn wall Red clay fill Slope 12" to 30" deep and remains 30" deep for 45 Ft

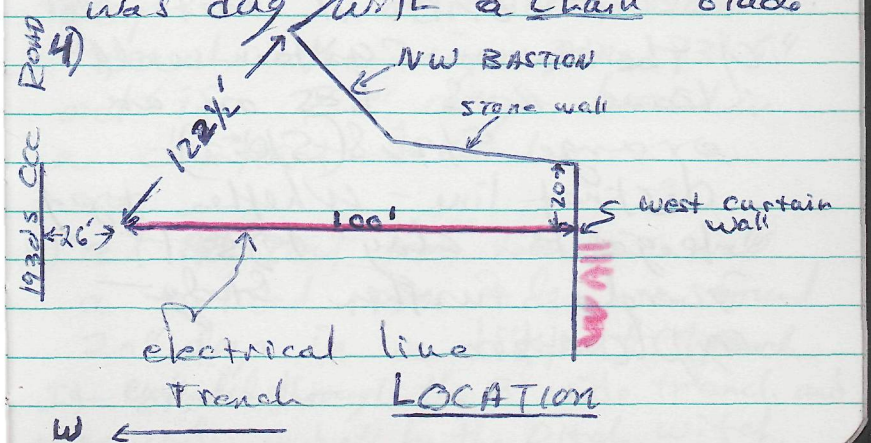
3) The DITCH WITCH model R40 dug a 8 inch wide trench 30 to 36 inches deep. The trend was dug with a Chain blade

5) black humus streak (lens) below top soil extends from 3 to 8 ft out (west)

6) From 10 to 39 ft out (west) a loose Rock rubble lens was found 12" - 18" deep Numerous large granite rock could had been intended for construction of stone FORT or its 1930's reconstruction period
